**Flood Control Project Maintenance
Levee Inspections**

Maintenance Issue Types Only, Levee Inspection Report By Mile - Spring 2019

Sutter Maintenance Yard Maintenance Area 0013

Waterway	Bank	Unit Miles	Inspection Start/End	Inspector
Unit No. 01 Cherokee Canal	Right	18.19	05/15/2019 05/15/2019	Makar Sokol

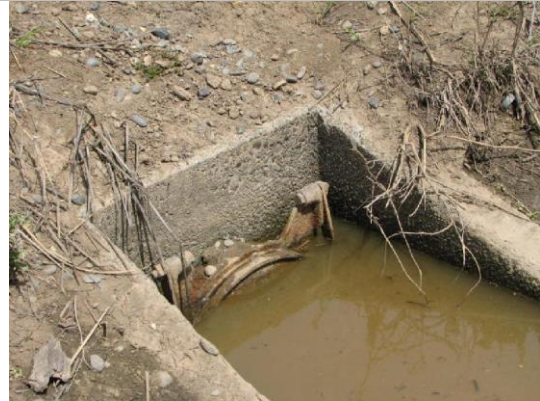
Photo 1 of 3 : UCIP_SP_2019_53315_66970.jpg

Comment Code					
Inspector Comment					
FS_ID:53315 DS_ID:16338 EP_NO: N/A Repair Type: Non-Urgent Crossing Status: Found UCIP Comments: 8/23/2018 WS flapgate has been replaced. LS outlet still has a lot of vegetation, but overall levee integrity looks good at time of this inspection. Downgrading to Non-Urgent from Urgent due to fixed flapgate and current levee condition (D. Sanoski - DWR UCIP).6/15/2017 Not abandoned- WS flapgate was dug out and opened draining water from the LS ditch. WS flapgate is heavily corroded and has a broken hinge- needs to be replaced. LS is still very overgrown and needs to be cleared. Pipe has been selected to be internally cleaned and inspected as part of the DMP project. (DWR Sutter Yard- AFreitag)11/17/2016 Appears abandoned. WS flap gate completely silted over and LS screw gate is completely overgrown by a tree and is not accessible for inspection. (DWR Sutter Yard- AFreitag)5/3/2016 Crossing appears to be abandoned. WS flap gate was completely silted over and LS slide gate is very overgrown by a tree.7/13/2015 WS flap gate is blocked from opening by sediment and vegetation. Needs to be cleared away. LS opening is being over grown by a tree and needs to be cutback.5/22/2014 Same as last inspection.12/3/2013 Same as last inspection.7/15/2013 Same as last inspection.4/18/2012 Tree has fallen at LS inlet and damaged slide gate. The tree needs to be removed and screw gate repaired. Limited inspection on LS due to fallen tree. FIELD_STRUCT_DESC: 24-inch corrugated metal drainage pipe through the levee, 12.7 feet below the crown. Flap gate on the waterside (WS). Concrete "U" headwall on both ends. [Additional Reference(s): DWR Levee Log, 1993. USACE Sacramento O&M Manual 519, June 1962 (HLM 13.96)] FS Date: 8/23/2018 2:42:00 PM

WS headwall and flap gate.

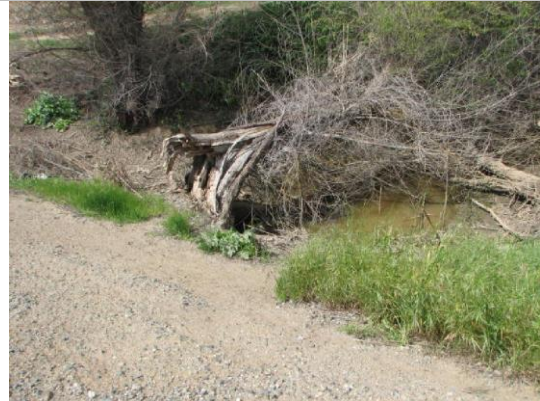
Photo 3 of 3 : UCIP_SP_2019_53315_66969.jpg

FS_ID:53315
 DS_ID:16338
 EP_NO: N/A
 Repair Type: Non-Urgent
 Crossing Status: Found
 UCIP Comments: 8/23/2018 WS flapgate has been replaced. LS outlet still has a lot of vegetation, but overall levee integrity looks good at time of this inspection. Downgrading to Non-Urgent from Urgent due to fixed flapgate and current levee condition (D. Sanoski - DWR UCIP).6/15/2017 Not abandoned- WS flapgate was dug out and opened draining water from the LS ditch. WS flapgate is heavily corroded and has a broken hinge- needs to be replaced. LS is still very overgrown and needs to be cleared. Pipe has been selected to be internally cleaned and inspected as part of the DMP project. (DWR Sutter Yard- AFreitag)11/17/2016 Appears abandoned. WS flap gate completely silted over and LS screw gate is completely overgrown by a tree and is not accessible for inspection. (DWR Sutter Yard- AFreitag)5/3/2016 Crossing appears to be abandoned. WS flap gate was completely silted over and LS slide gate is very overgrown by a tree.7/13/2015 WS flap gate is blocked from opening by sediment and vegetation. Needs to be cleared away. LS opening is being overgrown by a tree and needs to be cutback.5/22/2014 Same as last inspection.12/3/2013 Same as last inspection.7/15/2013 Same as last inspection.4/18/2012 Tree has fallen at LS inlet and damaged slide gate. The tree needs to be removed and screw gate repaired. Limited inspection on LS due to fallen tree.

Tree fallen at LS headwall.

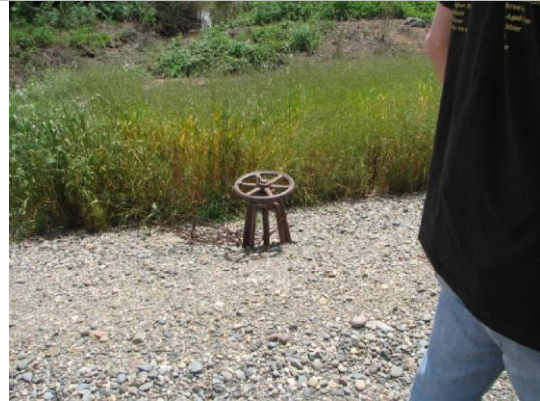
Photo 1 of 2 : UCIP_SP_2019_52240_66972.jpg

Comment Code					
Inspector Comment					
FS_ID:52240 DS_ID:16339 EP_NO: N/A Repair Type: Non-Urgent Crossing Status: Found UCIP Comments: 6/15/2017 Abandoned- still only the structure on the WS shoulder found. (DWR Sutter Yard- A Freitag)11/17/2016 Abandoned. (DWR Sutter Yard- A Freitag)5/03/2016 ABANDONED CROSSING7/13/2015 Abandoned crossing. Slide gate is buried on the WS.5/22/2014 Same as last inspection.12/3/2013 Same as last inspection.7/15/2013 Same as last inspection.4/18/2012 Non-functional crossing-buried slide gate on WS. Limited inspection on WS and LS slope/toe due to dense vegetation. Need photo of cleared WS & LS slopes or toe.This crossing is listed in the USACE periodic inspection report as Corp's Inspection ID# USACE_CESPK_M13D_2011_p_0352 for abandoned gate on WS slope. FIELD_STRUCT_DESC: *ABANDONED* 12-inch steel drainage pipe through the levee, 3 feet below the crown. Gate valve on the waterside (WS) slope. 0.25-inch steel plate welded on both ends. [Additional Reference(s): DWR Levee Log, 1993. USACE Sacramento O&M Manual 519, June 1962 (HLM 13.97)] FS Date: 6/19/2017 1:53:35 PM

Buried slide gate on the WS slope.

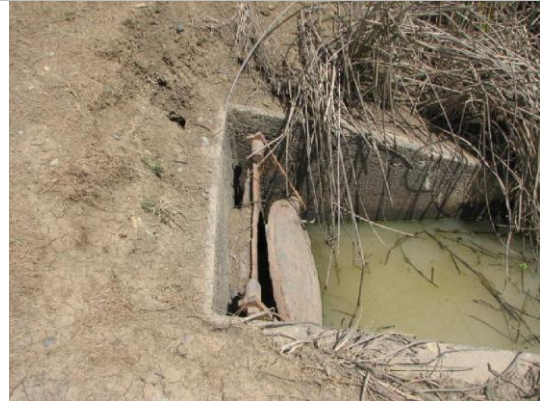
Photo 1 of 3 : UCIP_SP_2019_53317_66976.jpg

FS_ID:53317
DS_ID:16368
EP_NO: N/A
Repair Type: Urgent
Crossing Status: Found
UCIP Comments: 8/23/2018 WS pipe unable to be inspected due to heavy vegetation at inlet, so assume same as last inspection. Noticed a long crack a couple feet above WS headwall that could be of concern; possible future slough if soil gets saturated during next high water event and could be a sign of internal pipe degradation. LS outlet and slope looked good. Urgent due to long crack, obstructed inspection view of WS inlet, and 2016 photos of holes in pipe (D. Sanoski - DWR UCIP).6/15/2017 WS pipe end still showing heavy signs of corrosion and deterioration with visible holes between the concrete headwall and flap gate flange. Pipe was almost 100% full of water so could not visually inspect inside of the pipe to see if theres any damage inside of the levee segment. Pipe has been selected to be internally cleaned and inspected as part of the DMP project. (DWR Sutter Yard-AFreitag)11/17/2016 Top of pipe on WS still showing heavy signs of corrosion with visible holes between the flapgate flange and the concrete headwall. The pipe was mostly underwater so could not internally inspect it for more damage or corrosion. (DWR Sutter Yard-AFreitag)5/03/2016 Top of the pipe on the WS has holes in it between the flapgate flange and headwall. Crossing is showing signs of rust and deterioration but it was mostly underwater so could not inspect the inside of the pipe. (DWR Sutter Yard - afreitag)7/13/2015 Both sides of crossing were underwater at the time of inspection. (DWR Sutter Yard - afreitag)5/22/2014 Same as last inspection. (DWR Sutter Yard - afreitag)12/3/2013 Same as last inspection. (DWR Sutter Yard - afreitag)7/15/2013 Slopes have been cleared of vegetation and are in good condition. WS flapgate is still lodged open. (DWR Sutter Yard - afreitag)4/18/2012 Limited inspection on LS slope due to dense vegetation. Need photos of cleared WS & LS slopes. The flap gate is lodged open. (DWR UCIP - omagana)

Headwall and flapgate located on water side of levee

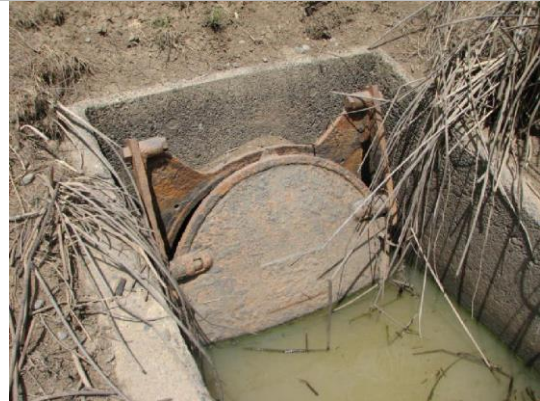
Photo 2 of 3 : UCIP_SP_2019_53317_66974.jpg

Headwall and flapgate located on water side of levee

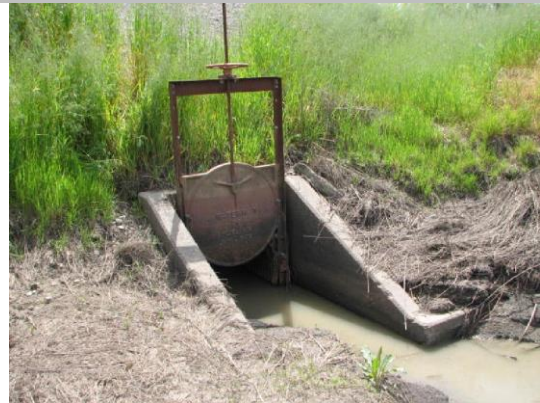
Photo 3 of 3 : UCIP_SP_2019_53317_66975.jpg

Head wall and screw gate located on land side of levee

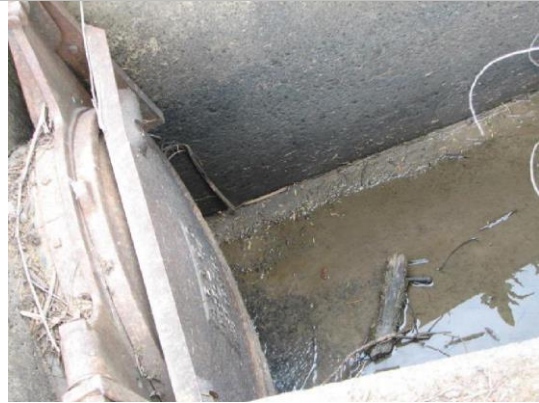
Photo 1 of 3 : UCIP_SP_2019_52242_66981.jpg

WS headwall and flapgate

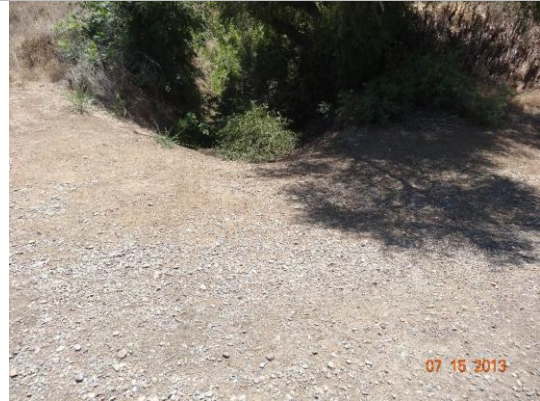
Photo 3 of 3 : UCIP_SP_2019_52242_66982.jpg

WS slope cleared of vegetation

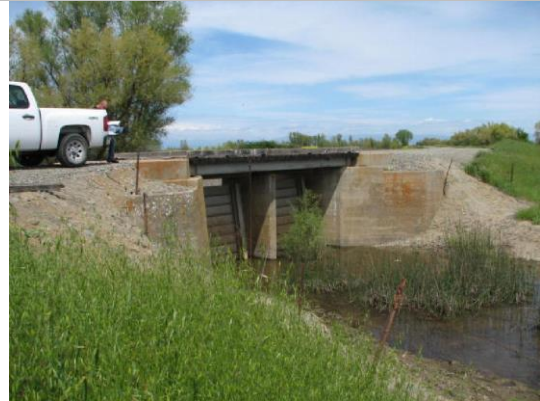
Photo 1 of 3 : UCIP_SP_2019_52245_74500.jpg

Comment Code					
Inspector Comment					
FS_ID:52245 DS_ID:16372 EP_NO: N/A Repair Type: No Action Needed Crossing Status: Found UCIP Comments: 6/15/2017 Crossing appears to be in good condition. Pipe has been selected to be internally cleaned and inspected as part of the DMP project. (DWR Sutter Yard- AFreitag)11/17/2016 Crossing appears to be in good condition. (DWR Sutter Yard- AFreitag)5/03/2016 Crossing appears to be in good condition. 7/13/2015 Crossing appears in good condition. No noticeable issues to report.5/22/2014 Same as last inspection.12/3/2013 Same as last inspection.7/15/2013 Same as last inspection.4/18/2012 The structures are closed with metal stop logs (weir type structure). The stop logs appear to be removable, however; there is a wooden bridge over the structure that would have to be removed in order to raise the stop logs. There is 1-foot of clearance between the bottom of the bridge and the top of the stop logs. FIELD_STRUCT_DESC: Two 10-foot by 10-foot concrete drain openings through the levee at an unknown depth below the crown. Wooden bridge, 10 ton load limit. [Additional Reference(s): DWR Levee Log, 1993. USACE Sacramento O&M Manual 519, June 1962 (HLM 16.43)] FS Date: 6/19/2017 2:09:30 PM

WS view of structure.

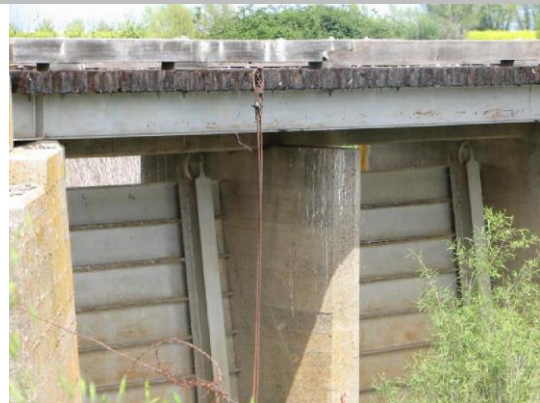
Photo 2 of 3 : UCIP_SP_2019_52245_74503.jpg

View of crossing and panels attached to concrete walls.

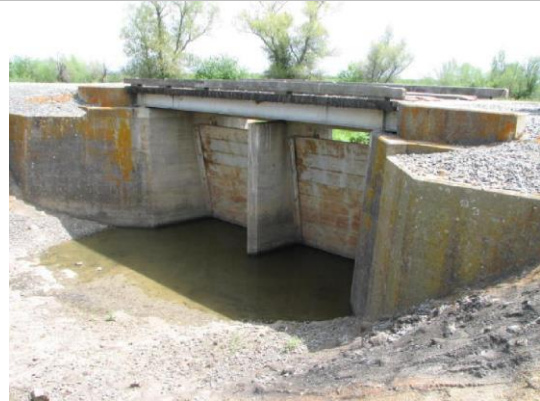
Photo 3 of 3 : UCIP_SP_2019_52245_74501.jpg

Item	DWR UCIP LMA Responsibility			39.394748 °	39.394748 °	
				-121.817360 °	-121.817360 °	
DWR ID	16372					
Comment Code						
Inspector Comment						
FS_ID:52245 DS_ID:16372 EP_NO: N/A Repair Type: No Action Needed Crossing Status: Found UCIP Comments: 6/15/2017 Crossing appears to be in good condition. Pipe has been selected to be internally cleaned and inspected as part of the DMP project. (DWR Sutter Yard- AFreitag)11/17/2016 Crossing appears to be in good condition. (DWR Sutter Yard- AFreitag)5/03/2016 Crossing appears to be in good condition. 7/13/2015 Crossing appears in good condition. No noticeable issues to report. 5/22/2014 Same as last inspection. 12/3/2013 Same as last inspection. 7/15/2013 Same as last inspection. 4/18/2012 The structures are closed with metal stop logs (weir type structure). The stop logs appear to be removable, however; there is a wooden bridge over the structure that would have to be removed in order to raise the stop logs. There is 1-foot of clearance between the bottom of the bridge and the top of the stop logs. FIELD_STRUCT_DESC: Two 10-foot by 10-foot concrete drain openings through the levee at an unknown depth below the crown. Wooden bridge, 10 ton load limit. [Additional Reference(s): DWR Levee Log, 1993. USACE Sacramento O&M Manual 519, June 1962 (HLM 16.43)] FS Date: 6/19/2017 2:09:30 PM

LS view of structure

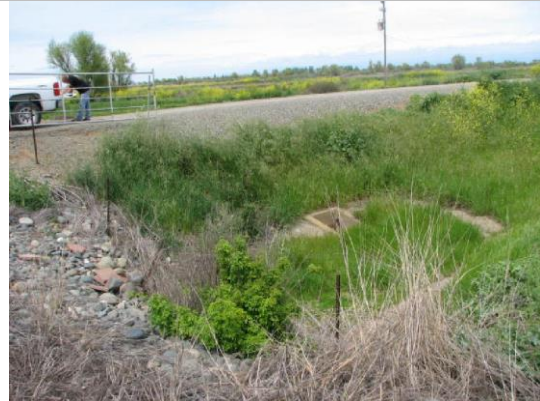
Photo 1 of 3 : UCIP_SP_2019_52249_67017.jpg

Comment Code						
Inspector Comment						
FS_ID:52249 DS_ID:16369 EP_NO: N/A Repair Type: Non-Urgent Crossing Status: Found UCIP Comments: 6/15/2017 Flapgate bolted shut. Hinges seem very stiff to operate as gate will not fully close and has about a 1/2" gap near the top. Land owner claims the gate leaks during high water times. Pipe has been selected to be internally cleaned and inspected as part of the DMP project. (DWR Sutter Yard- AFreitag)11/17/2016 Crossing appears to be in good condition. (DWR Sutter Yard- AFreitag)5/03/2016 Crossing appears to be in good condition. 7/13/2015 WS flap gate is blocked from opening by sediment. Needs to be dug out.5/22/2014 Same as last inspection.12/3/2013 Sediment was dug out from WS flapgate allowing it to open.7/15/2013 Slopes have been sprayed and cleared of vegetation and are in good condition. WS flapgate is blocked from opening by sediment buildup.4/18/2012 Limited inspection on WS and LS slope due to dense vegetation and steep slopes. Need photos of cleared WS & LS slopes. FIELD_STRUCT_DESC: 24-inch corrugated metal drainage pipe through the levee, 8.1 feet below the crown. Flap gate on the waterside (WS). Concrete "U" headwalls on both WS and landside (LS). [Additional Reference(s): DWR Levee Log, 1993. USACE Sacramento O&M Manual 519, June 1962 (HLM 17.47)] FS Date: 6/19/2017 2:20:18 PM

View of WS slope and toe.

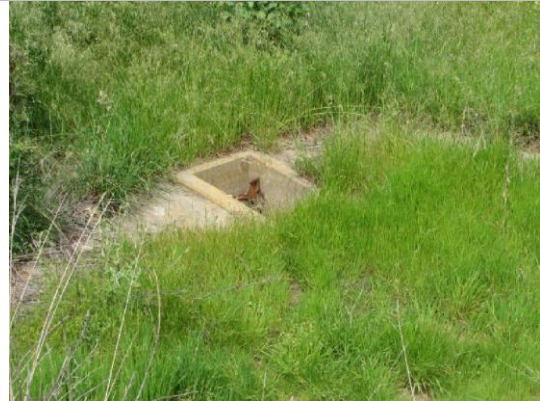
Photo 2 of 3 : UCIP_SP_2019_52249_67019.jpg

Item	DWR UCIP LMA Responsibility			39.385172 °	39.385172 °	
				-121.832060 °	-121.832060 °	
DWR ID	16369					
Comment Code						
Inspector Comment						
FS_ID:52249 DS_ID:16369 EP_NO: N/A Repair Type: Non-Urgent Crossing Status: Found UCIP Comments: 6/15/2017 Flapgate bolted shut. Hinges seem very stiff to operate as gate will not fully close and has about a 1/2" gap near the top. Land owner claims the gate leaks during high water times. Pipe has been selected to be internally cleaned and inspected as part of the DMP project. (DWR Sutter Yard- AFreitag)11/17/2016 Crossing appears to be in good condition. (DWR Sutter Yard- AFreitag)5/03/2016 Crossing appears to be in good condition.7/13/2015 WS flap gate is blocked from opening by sediment. Needs to be dug out.5/22/2014 Same as last inspection.12/3/2013 Sediment was dug out from WS flapgate allowing it to open.7/15/2013 Slopes have been sprayed and cleared of vegetation and are in good condition. WS flapgate is blocked from opening by sediment buildup.4/18/2012 Limited inspection on WS and LS slope due to dense vegetation and steep slopes. Need photos of cleared WS & LS slopes. FIELD_STRUCT_DESC: 24-inch corrugated metal drainage pipe through the levee, 8.1 feet below the crown. Flap gate on the waterside (WS). Concrete "U" headwalls on both WS and landside (LS). [Additional Reference(s): DWR Levee Log, 1993. USACE Sacramento O&M Manual 519, June 1962 (HLM 17.47)] FS Date: 6/19/2017 2:20:18 PM

View of WS headwall and flap gate.

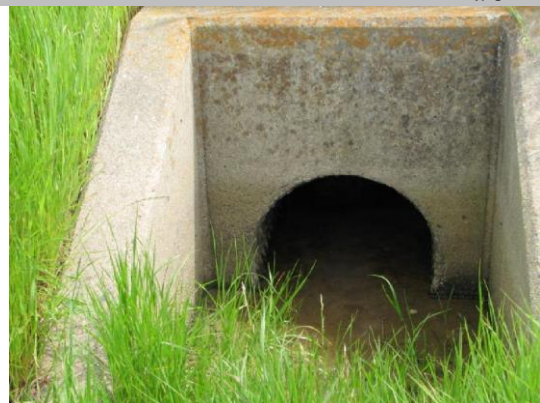
Photo 3 of 3 : UCIP_SP_2019_52249_67018.jpg

View of LS headwall.

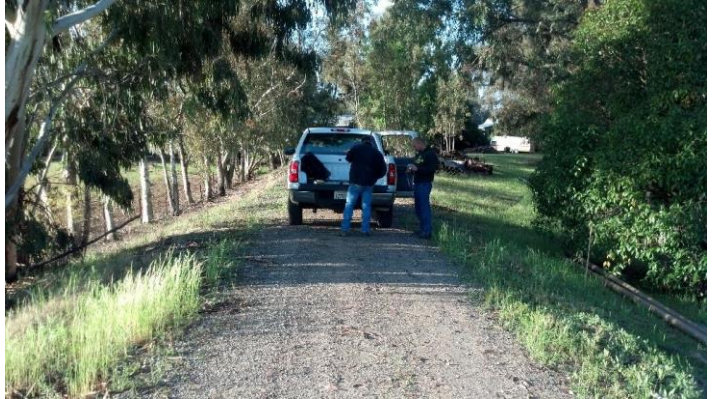
Photo 1 of 3 : UCIP_SP_2019_52111_45640.jpg

FS_ID:52111
DS_ID:16397
EP_NO: N/A
Repair Type: Non-Urgent
Crossing Status: Found
UCIP Comments: 6/5/2017 Crossing appears to be in good condition. (DWR Sutter Yard- AFreitag)11/18/2016 Crossing appears to be in good condition. 4inch pipe still present on LS but it does not affect the function of the crossing. (DWR Sutter Yard- AFreitag)9/27/2016 Crossing has been downgraded from Urgent to Non-Urgent--sleeved pipe does not prevent flap gate from closing on WS. Still need to coordinate with owner to remove sleeved pipe through existing crossing per Title 23. (DWR UCIP - omagana)4/27/2016 Crossing appears to be in good condition. 4 inch pipe is still present in LS opening but does not go all the way through to the WS. (DWR Sutter Yard - afreitag)7/01/2015 Crossing appears in good condition. No noticeable issues to report. (DWR Sutter Yard - afreitag)5/29/2014 Same as last inspection. (DWR Sutter Yard - afreitag)12/9/2013 4in. Pipe was removed and flapgate is closed and ready for high water. (DWR Sutter Yard - afreitag)7/10/2013 Same as last inspection. Urgency rating carry over from last entry. (DWR Sutter Yard - afreitag)4/19/2012 4-6 inch pipe is not part of original crossing--remove pipe. WS-pipe stockpile on WS slope. LS-Overgrown branches limit inspection. This crossing was listed in the USACE Periodic Inspection report listed as Corp's Inspect ID# USACE_CESPK_M13G_2011_p_0009 for WS flap gate not functioning properly as irrigation pipe passes inside crossing. (DWR UCIP - omagana)

Overview looking south on left levee

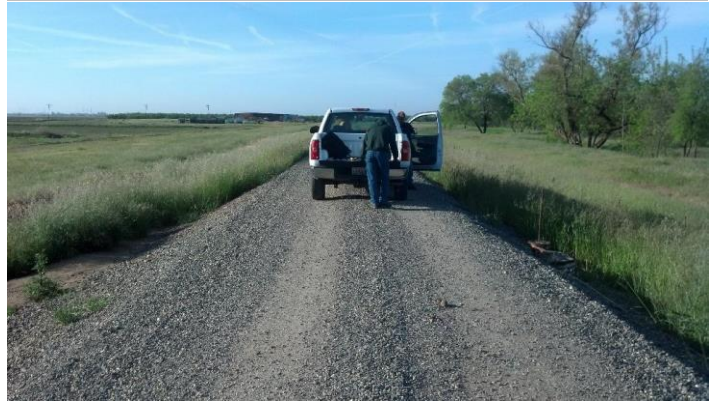
Photo 1 of 3 : UCIP_SP_2019_52112_67047.jpg

FS_ID:52112
DS_ID:16398
EP_NO: N/A
Repair Type: Non-Urgent
Crossing Status: Found
UCIP Comments: 6/5/2017 LS ditch at outlet is getting over grown with vegetation. WS near concrete standpipe is overgrown with vegetation. Pipe has been selected to be internally cleaned and inspected as part of the DMP project. (DWR Sutter Yard- A/Freitag)11/18/2016 Between the screwgate on the WS shoulder and the LS pipe end the pipe is about 50% full of soil. Crossing is still actively used by landowner for irrigation purposes. (DWR Sutter Yard- A/Freitag)4/27/2016 Pipe gets used by the landowner to irrigate his rice fields. It appeared to be in good condition.7/01/2015 LS pipe end is still about 50% full of sediment.5/29/2014 Same as last inspection.12/9/2013 Same as last inspection.7/10/2013 LS and WS slopes have been cleared of vegetation and are in good condition. LS pipe end is half full of sediment. Sediment inside of WS standpipe may hinder slide gate from fully closing. Standpipe cover is still broken.4/19/2012 Need to fix the top of slide gate cover. The wooden cap on standpipe is broken. Limited evaluation of crossing due to dense vegetation on LS slope. Need photos of cleared slopes during fall inspection.

Overview looking south

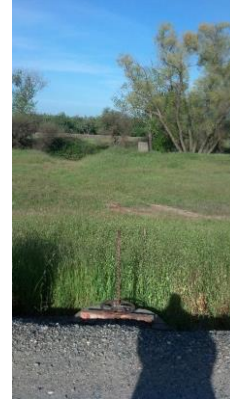
Photo 2 of 3 : UCIP_SP_2019_52112_67048.jpg

Comment Code						
Inspector Comment						
FS_ID:52112 DS_ID:16398 EP_NO: N/A Repair Type: Non-Urgent Crossing Status: Found UCIP Comments: 6/5/2017 LS ditch at outlet is getting over grown with vegetation. WS near concrete standpipe is overgrown with vegetation. Pipe has been selected to be internally cleaned and inspected as part of the DMP project. (DWR Sutter Yard- AFreitag)11/18/2016 Between the screwgate on the WS shoulder and the LS pipe end the pipe is about 50% full of soil. Crossing is still actively used by landowner for irrigation purposes. (DWR Sutter Yard- AFreitag)4/27/2016 Pipe gets used by the landowner to irrigate his rice fields. It appeared to be in good condition.7/01/2015 LS pipe end is still about 50% full of sediment.5/29/2014 Same as last inspection.12/9/2013 Same as last inspection.7/10/2013 LS and WS slopes have been cleared of vegetation and are in good condition. LS pipe end is half full of sediment. Sediment inside of WS standpipe may hinder slide gate from fully closing. Standpipe cover is still broken.4/19/2012 Need to fix the top of slide gate cover. The wooden cap on standpipe is broken. Limited evaluation of crossing due to dense vegetation on LS slope. Need photos of cleared slopes during fall inspection. FIELD_STRUCT_DESC: 24-inch corrugated metal drainage pipe through the levee, 10.6 feet below the crown. Slide gate in corrugated metal pipe (CMP) riser on the waterside (WS) slope. Concrete "U" headwall on the landside (LS). 36-inch concrete standpipe in the channel with two wooden piles to deflect debris. [Additional Reference(s): DWR Levee Log, 1993. USACE Sacramento O&M Manual 519, June 1962 (HLM 0.57)] FS Date: 6/7/2017 12:03:30 PM

View of WS slope and toe.

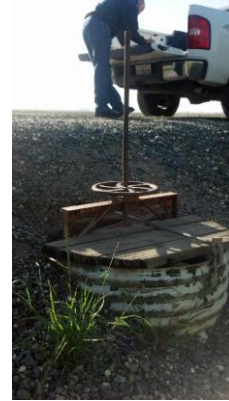
Photo 3 of 3 : UCIP_SP_2019_52112_67045.jpg

Comment Code						
Inspector Comment						
FS_ID:52112 DS_ID:16398 EP_NO: N/A Repair Type: Non-Urgent Crossing Status: Found UCIP Comments: 6/5/2017 LS ditch at outlet is getting over grown with vegetation. WS near concrete standpipe is overgrown with vegetation. Pipe has been selected to be internally cleaned and inspected as part of the DMP project. (DWR Sutter Yard- AFreitag)11/18/2016 Between the screwgate on the WS shoulder and the LS pipe end the pipe is about 50% full of soil. Crossing is still actively used by landowner for irrigation purposes. (DWR Sutter Yard- AFreitag)4/27/2016 Pipe gets used by the landowner to irrigate his rice fields. It appeared to be in good condition.7/01/2015 LS pipe end is still about 50% full of sediment.5/29/2014 Same as last inspection.12/9/2013 Same as last inspection.7/10/2013 LS and WS slopes have been cleared of vegetation and are in good condition. LS pipe end is half full of sediment. Sediment inside of WS standpipe may hinder slide gate from fully closing. Standpipe cover is still broken.4/19/2012 Need to fix the top of slide gate cover. The wooden cap on standpipe is broken. Limited evaluation of crossing due to dense vegetation on LS slope. Need photos of cleared slopes during fall inspection. FIELD_STRUCT_DESC: 24-inch corrugated metal drainage pipe through the levee, 10.6 feet below the crown. Slide gate in corrugated metal pipe (CMP) riser on the waterside (WS) slope. Concrete "U" headwall on the landside (LS). 36-inch concrete standpipe in the channel with two wooden piles to deflect debris. [Additional Reference(s): DWR Levee Log, 1993. USACE Sacramento O&M Manual 519, June 1962 (HLM 0.57)] FS Date: 6/7/2017 12:03:30 PM

Screw gate located on WS of levee. Screw gate covers needs to be repaired.

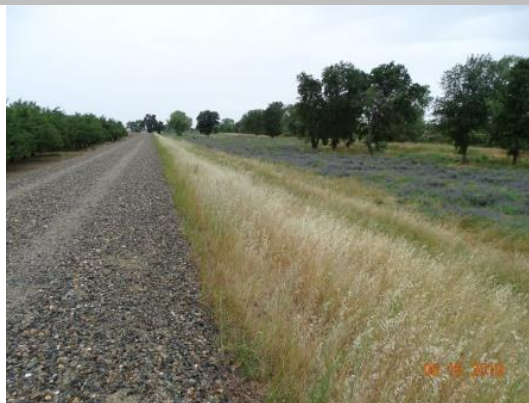
Photo 1 of 1 : SP_2019_MA0013_301_58_20190520_00131.jpg

LM Start	0.70	Rating **	U	Issue No.	58
LM End	4.15	Issue Type +	Ma	Location *	WS
Category	Earthen Levee			GPS Latitude/Longitude	
				Start	End
Item	Vegetation			39.564675 °	39.528043 °
				-121.702383 °	-121.698592 °
DWR ID	DWR_MA0013_02_s_2019_58				
Comment Code					
V1 : Control annual grass and weeds on the levee slopes and easements.					
Inspector Comment

View of the vegetation on the waterside slope. Spring 2019.

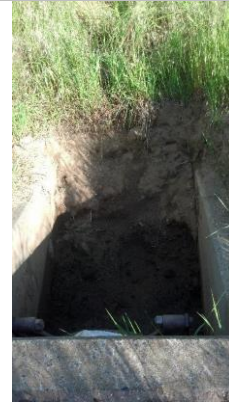
Photo 3 of 3 : UCIP_SP_2019_52114_67057.jpg

Comment Code						
Inspector Comment						
FS_ID:52114 DS_ID:16399 EP_NO: N/A Repair Type: Non-Urgent Crossing Status: Found UCIP Comments: 6/5/2017 LS slide gate stem is bent and the gate appears as if it will not open. LS inlet is becoming heavily vegetated next to rice field. WS flap gate is blocked shut by sediment. Pipe has been selected to be internally cleaned and inspected as part of the DMP project. (DWR Sutter Yard- AFreitag)11/18/2016 LS screw gate still bent and in-operable. (DWR Sutter Yard- AFreitag)4/27/2016 LS screw gate is still bent. Rest of crossing appeared in good condition.7/01/2015 LS screw gate frame is still twisted and hindering the gate from opening.5/29/2014 Same as last inspection.12/9/2013 Same as last inspection.7/10/2013 WS slope is cleared of vegetation and is in good condition. LS screw gate frame is twisted and is preventing the gate from opening.4/19/2012 Limited inspection dense vegetation on WS. Need photos of clear WS slope & toe. Ditch present in channel? This crossing was listed in the USACE Periodic Inspection report as Corp's Inspect ID# USACE_CESPK_M13G_2011_p_0108 for WS flap gate filled with soil and LS gate not functioning because of overgrown vegetation. FIELD_STRUCT_DESC: 24-inch corrugated metal drainage pipe through the levee, 7.9 feet below the crown. Concrete "U" headwalls on both waterside (WS) and landside (LS) ends. Flap gate on the WS end. Slide gate at the LS toe in headwall. In 1962, permit number 3953 was issue for existing pump structure, intake box, ditch and power pole. In 1963, the pump and intake box were removed. (Permit No. 3953, 1960 - Dr. John O. Gibbs, DBA Empire Land Company) [Additional Reference(s): DWR Levee Log, 1993. USACE Sacramento O&M Manual 519, June 1962 (HLM 1.70)] FS Date: 6/7/2017 12:14:04 PM

View of WS toe.

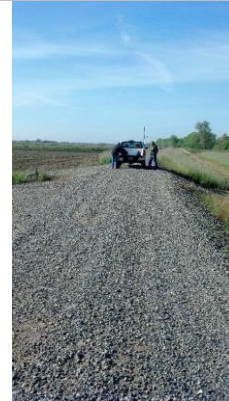
Photo 1 of 3 : UCIP_SP_2019_52115_67063.jpg

Comment Code						
Inspector Comment						
FS_ID:52115 DS_ID:16400 EP_NO: N/A Repair Type: No Action Needed Crossing Status: Found UCIP Comments: 6/5/2017 LS inlet was underwater. WS flapgate blocked shut by sediment. Pipe has been selected to be internally cleaned and inspected as part of the DMP project. (DWR Sutter Yard-AFreitag)11/18/2016 Sediment dug out from in front of flap gate. Gate can now function properly. (DWR Sutter Yard-AFreitag)4/27/2016 WS flapgate still blocked from opening by sediment buildup.7/01/2015 New screwgate installed on the LS. WS flapgate is still blocked from opening by sediment.5/29/2014 Same as last inspection.12/9/2013 Same as last inspection.7/10/2013 Sediment is built up against WS flap gate not allowing it to open. Handle for LS slide gate is still missing.4/19/2012 Handle missing on slide gate. FIELD_STRUCT_DESC: 1 of 2: 36-inch corrugated metal drainage pipe through the levee, 9.7 feet below the crown. Concrete "U" headwalls located on the waterside (WS) and landside (LS) ends. Flap gate on the WS end. Slide gate on the LS end. [Additional Reference(s): DWR Levee Log, 1993. USACE Sacramento O&M Manual 519, June 1962 (HLM 2.54)] FS Date: 6/7/2017 12:18:14 PM

Overview of levee crown looking south

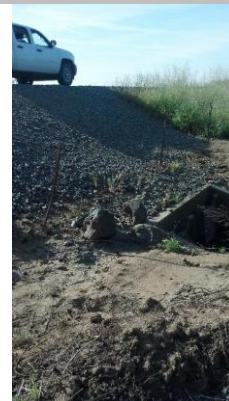
Photo 2 of 3 : UCIP_SP_2019_52115_67068.jpg

View of WS slope.

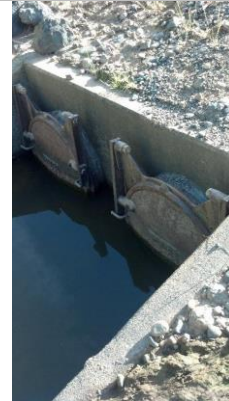
Photo 3 of 3 : UCIP_SP_2019_52115_67064.jpg

Item	DWR UCIP LMA Responsibility			39.539195°	39.539195°	
				-121.706070°	-121.706070°	
DWR ID	16400					
Comment Code						
Inspector Comment						
FS_ID:52115 DS_ID:16400 EP_NO: N/A Repair Type: No Action Needed Crossing Status: Found UCIP Comments: 6/5/2017 LS inlet was underwater. WS flapgate blocked shut by sediment. Pipe has been selected to be internally cleaned and inspected as part of the DMP project. (DWR Sutter Yard-AFreitag)11/18/2016 Sediment dug out from in front of flap gate. Gate can now function properly. (DWR Sutter Yard-AFreitag)4/27/2016 WS flapgate still blocked from opening by sediment buildup.7/01/2015 New screwgate installed on the LS. WS flapgate is still blocked from opening by sediment.5/29/2014 Same as last inspection.12/9/2013 Same as last inspection.7/10/2013 Sediment is built up against WS flap gate not allowing it to open. Handle for LS slide gate is still missing.4/19/2012 Handle missing on slide gate. FIELD_STRUCT_DESC: 1 of 2: 36-inch corrugated metal drainage pipe through the levee, 9.7 feet below the crown. Concrete "U" headwalls located on the waterside (WS) and landside (LS) ends. Flap gate on the WS end. Slide gate on the LS end. [Additional Reference(s): DWR Levee Log, 1993. USACE Sacramento O&M Manual 519, June 1962 (HLM 2.54)] FS Date: 6/7/2017 12:18:14 PM

Headwall and flap gates (2) located on WS

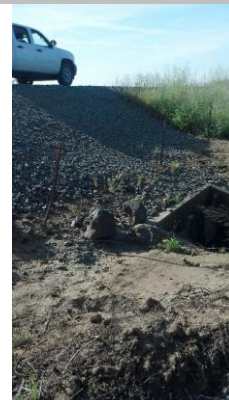
Photo 2 of 3 : UCIP_SP_2019_52116_67074.jpg

Comment Code						
Inspector Comment						
FS_ID:52116						
DS_ID:17169						
EP_NO: N/A						
Repair Type: No Action Needed						
Crossing Status: Found						
UCIP Comments: 6/5/2017 LS inlet was underwater. WS appears to be in good condition. Pipe has been selected to be internally cleaned and inspected as part of the DMP project. (DWR Sutter Yard- A/Freitag)11/18/2016 Crossing appears to be in good condition. (DWR Sutter Yard- A/Freitag)4/27/2016 Crossing appears to be in good condition.7/01/2015 New screwgate installed on the LS. WS appears to be in good condition.5/29/2014 Same as last inspection.12/9/2013 Same as last inspection.7/10/2013 Same as last inspection.						
FIELD_STRUCT_DESC: 2 of 2: 36-inch corrugated metal drainage pipe through the levee, 9.7 feet below the crown. Concrete "U" headwalls on both the waterside (WS) and landside (LS) ends. Flap gate on the waterside (WS) end. Slide gate on the landside (LS) end. [Additional Reference(s): DWR Levee Log, 1993. USACE Sacramento O&M Manual 519, June 1962 (HLM 2.54)]

View of WS slope.

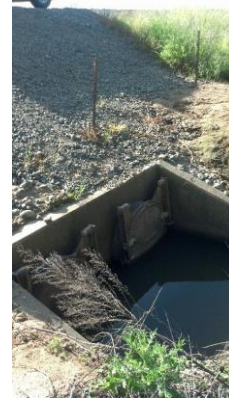
Photo 3 of 3 : UCIP_SP_2019_52116_67071.jpg

Item	DWR UCIP LMA Responsibility			39.539179 °	39.539179 °	
				-121.706060 °	-121.706060 °	
DWR ID	17169					
Comment Code						
Inspector Comment						
FS_ID:52116 DS_ID:17169 EP_NO: N/A Repair Type: No Action Needed Crossing Status: Found UCIP Comments: 6/5/2017 LS inlet was underwater. WS appears to be in good condition. Pipe has been selected to be internally cleaned and inspected as part of the DMP project. (DWR Sutter Yard- AFreitag)11/18/2016 Crossing appears to be in good condition. (DWR Sutter Yard- AFreitag)4/27/2016 Crossing appears to be in good condition.7/01/2015 New screwgate installed on the LS. WS appears to be in good condition.5/29/2014 Same as last inspection.12/9/2013 Same as last inspection.7/10/2013 Same as last inspection. FIELD_STRUCT_DESC: 2 of 2: 36-inch corrugated metal drainage pipe through the levee, 9.7 feet below the crown. Concrete "U" headwalls on both the waterside (WS) and landside (LS) ends. Flap gate on the waterside (WS) end. Slide gate on the landside (LS) end. [Additional Reference(s): DWR Levee Log, 1993. USACE Sacramento O&M Manual 519, June 1962 (HLM 2.54)] FS Date: 6/7/2017 12:28:51 PM

Headwall and flap gates (2) located on the WS.

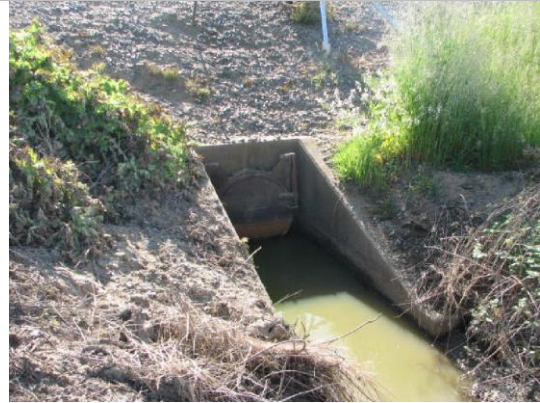
Photo 2 of 3 : UCIP_SP_2019_52117_67076.jpg

Comment Code						
Inspector Comment						
FS_ID:52117 DS_ID:16402 EP_NO: N/A Repair Type: Non-Urgent Crossing Status: Found UCIP Comments: 6/5/2017 Sediment blocking LS slide gate from closing fully. Pipe has been selected to be internally cleaned and inspected as part of the DMP project. (DWR Sutter Yard-AFreitag)11/18/2016 Sediment still blocking screw gate from fully closing. (DWR Sutter Yard- AFreitag)4/27/2016 LS slide gate is full of sediment and needs to be dug out so gate can close fully.7/01/2015 LS screwgate is still silted in and unable to be screwed down all the way. Needs to be cleaned out.5/29/2014 Same as last inspection.12/9/2013 WS flapgate was closed but LS slidegate is heavily vegetated and blocked from closing by sediment.7/10/2013 Same as last inspection.4/19/2012 Minor sediment built up on LS, remove sediment. Need photo of LS slide gate without sediment build up. This crossing was listed in the USACE Periodic Inspection report as Corp's inspect ID# USACE_CESPK_M13G_2011_p_0148 for LS gate obstructed by vegetation and WS flap gate is not functioning (propped open). FIELD_STRUCT_DESC: 36-inch corrugated metal drainage pipe through the levee, 8.8 feet below the crown. Concrete "U" headwalls located on both the waterside (WS) and landside (LS) ends. Flap gate on the WS end. Slide gate on the LS end. Structure used to drain water from Nelson Shippe Road. [Additional Reference(s): DWR Levee Log, 1993. USACE Sacramento O&M Manual 519, June 1962 (HLM 2.63)] FS Date: 6/7/2017 12:45:23 PM

Headwall and flap gate located on WS.

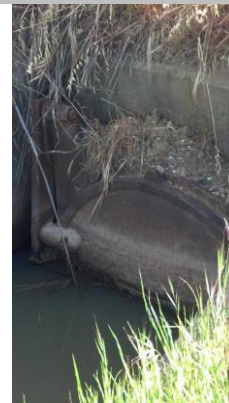
Photo 2 of 3 : UCIP_SP_2019_52119_67084.jpg

Headwall and flap gate located on WS

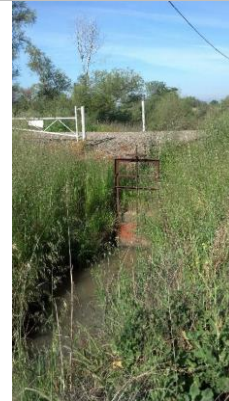
Photo 3 of 3 : UCIP_SP_2019_52119_67086.jpg

Headwall and screw gate located on the LS

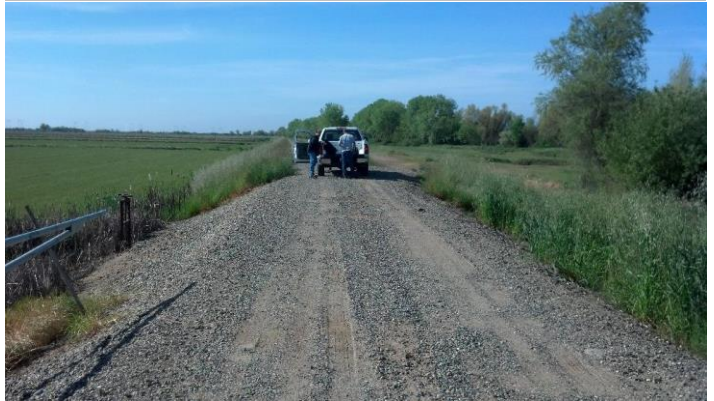
Photo 1 of 3 : UCIP_SP_2019_52120_67090.jpg

Comment Code						
Inspector Comment						
FS_ID:52120 DS_ID:16415 EP_NO: N/A Repair Type: Non-Urgent Crossing Status: Found UCIP Comments: 6/5/2017 Both gates partially submerged during site visit. Appears to be in good condition. Pipe has been selected to be internally cleaned and inspected as part of the DMP project. (DWR Sutter Yard- A Freitag)11/18/2016 LS screw gate closed but partially buried. WS flapgate was half submerged for inspection. (DWR Sutter Yard- A Freitag)4/27/2016 Both gates were underwater for inspection.7/01/2015 WS flap gate is partially held open by sediment and needs to be dug out to allow it to fully close.5/29/2014 Same as last inspection.12/9/2013 Both gates were out of water and in good condition.7/10/2013 LS and WS slopes are in good condition. Both LS and WS gates were fully submerged in water and unable to be inspected. FIELD_STRUCT_DESC: 36-inch corrugated metal drainage pipe through the levee, 9 feet below the crown. Concrete "U" headwall on both waterside (WS) and landside (LS) ends. Flap gate on the WS end. Slide gate on the LS. [Additional Reference(s): DWR Levee Log, 1993. USACE Sacramento O&M Manual 519, June 1962 (HLM 2.66)] FS Date: 6/7/2017 12:50:33 PM

Overview looking south from left levee

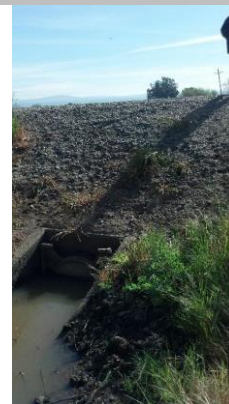
Photo 2 of 3 : UCIP_SP_2019_52120_67091.jpg

Headwall and flap gate located on WS.

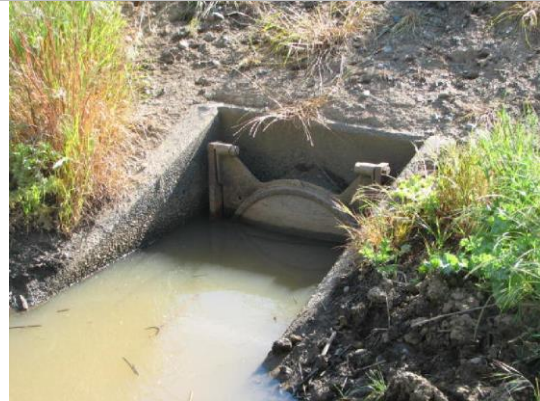
Photo 3 of 3 : UCIP_SP_2019_52120_67092.jpg

WS headwall and flap gate.

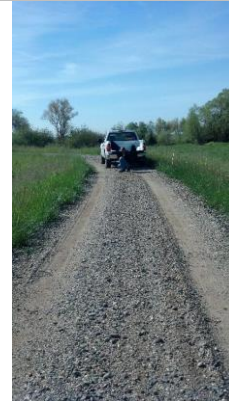
Photo 1 of 3 : UCIP_SP_2019_52121_67094.jpg

FS_ID:52121
DS_ID:16405
EP_NO: N/A
Repair Type: Non-Urgent
Crossing Status: Found
UCIP Comments: 6/5/2017 Abandoned- LS slide gate completely buried in rice field and WS flap gate almost fully buried. (DWR Sutter Yard- AFreitag)11/18/2016 appears abandoned. Both gates completely buried. (DWR Sutter Yard- AFreitag)4/27/2016 Crossing appears abandoned. LS screw gate still buried and WS flap gate was 95% buried.7/01/2015 Still a non functioning crossing. LS screw gate is completely buried by sediment with only part of its frame and stem visible. WS flapgate is blocked from opening by sediment and debris.5/29/2014 Same as last inspection.12/9/2013 LS slide gate is completely buried by soil and WS flap gate is blocked from opening by sediment. Crossing appears abandoned and non-function.

7/10/2013 LS and WS slopes have been cleared by vegetation and are in good condition. WS flap gate is out of water but is blocked from opening by sediment build up. LS gate is fully submerged and not able to be inspected.4/19/2012 Non-functioning crossing. Farmer uses pipe located at LM 3.682 to drain field & not this one. Dense vegetation-need photos of cleared WS & LS slopes. This crossing was listed in the USACE Periodic Inspection report as Corp's inspect ID# USACE_CESPK_M13G_2011_p_0172 for no access to WS gate due to high water & dense vegetation.

Overview looking south from left levee

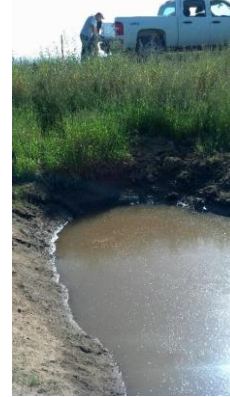
Photo 2 of 3 : UCIP_SP_2019_52121_67095.jpg

Flap gate submerged in water on WS of levee

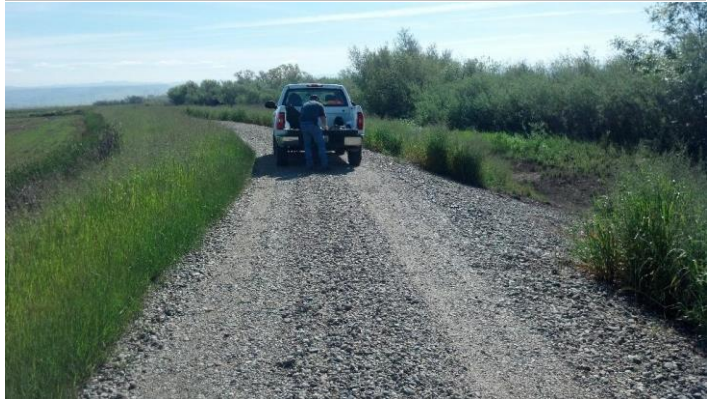
Photo 1 of 3 : UCIP_SP_2019_52122_67102.jpg

FS_ID:52122
DS_ID:16848
EP_NO: N/A
Repair Type: No Action Needed
Crossing Status: Found
UCIP Comments: 6/5/2017 Both ends submerged but appear to be in good condition. Pipe has been selected to be internally cleaned and inspected as part of the DMP project. (DWR Sutter Yard- A/Freitag)11/18/2016 Crossing appears to be in good condition. (DWR Sutter Yard- A/Freitag)4/27/2016 Crossing appears to be in good condition. New slide gate installed on LS.7/01/2015 Both gates were still submerged in water. Levee slopes were in good condition.5/29/2014 Same as last inspection.12/9/2013 Same as last inspection.7/10/2013 LS slope has been cleared of vegetation and is in good condition. Both gates are still underwater and not able to be inspected.4/19/2012 Dense vegetation makes it difficult to evaluate the condition of the LS slope. Both gates underwater. Recommend taking photos of clear slopes and gates during fall inspection.

Overview looking south on left levee

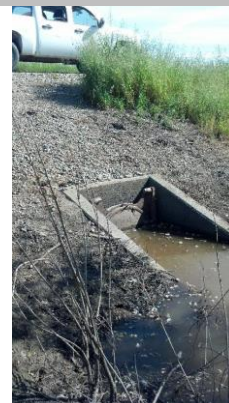
Photo 2 of 3 : UCIP_SP_2019_52122_67103.jpg

Headwall and flap gate located on WS.

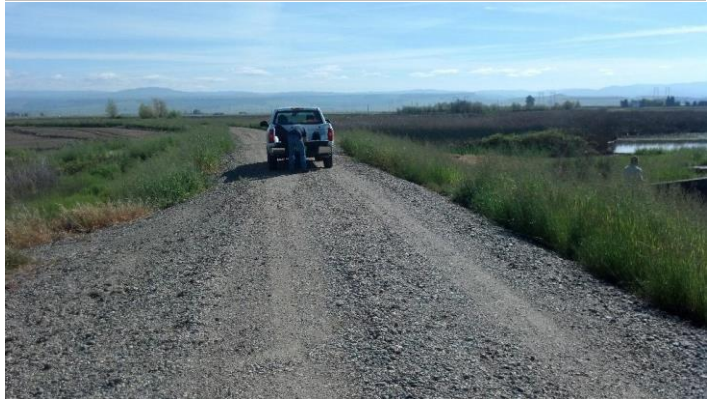
Photo 1 of 3 : UCIP_SP_2019_52123_67107.jpg

Comment Code					
Inspector Comment					
FS_ID:52123 DS_ID:16847 EP_NO: N/A Repair Type: Non-Urgent Crossing Status: Found UCIP Comments: 6/5/2017 Both ends submerged but crossing appears to be in good condition. (DWR Sutter Yard-AFreitag)11/18/2016 Crossing appears to be in good condition. It appears that this crossing does not require a slide gate. (DWR Sutter Yard- AFreitag)4/27/2016 LS slide gate was still missing. Rest of crossing appears to be in good condition.7/01/2015 There appears to be a LS gate now but both pipe ends were submerged so it was hard to tell for certain.5/29/2014 Same as last inspection.12/9/2013 Pulled sticks from WS flap gate to allow it to close. Ls gate is still missing.7/10/2013 WS and LS slopes have been cleared of vegetation and are in good condition. LS gate is still missing and WS flap gate is still wedged open with sticks.4/19/2012 LS gate missing & limited inspection. Need photos of WS & LS cleared slopes. Description calls for slide gate on LS-slide gate missing. Debris scattered near LS headwall. This crossing was listed in the USACE Periodic Inspection report as Corp's Inspect ID# USACE_CESPK_M13J_2011_p_0010 for WS gate wedged open & missing LS slide gate. FIELD_STRUCT_DESC: 36-inch corrugated metal drainage pipe through the levee, 8.8 feet below the crown. Flap gate on the waterside (WS) end. Slide gate on the landside (LS) end. Concrete "U" headwalls on both ends. [Additional Reference(s): DWR Levee Log, 1993. USACE Sacramento O&M Manual 519, June 1962 (HLM 3.85)] FS Date: 6/7/2017 1:24:40 PM

Overview looking south on left levee

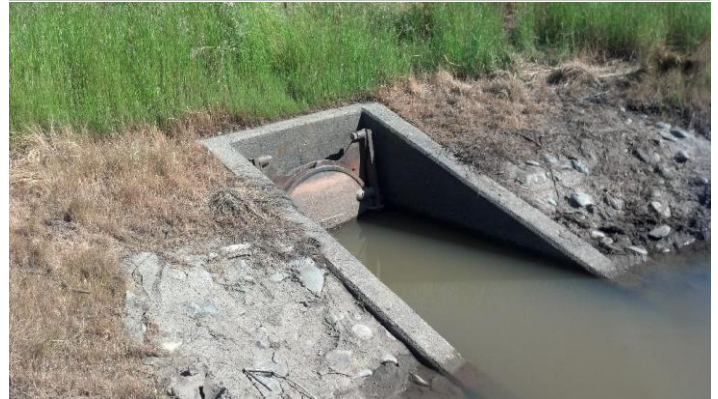
Photo 2 of 3 : UCIP_SP_2019_52123_67108.jpg

Headwall and flap gate located on WS toe.

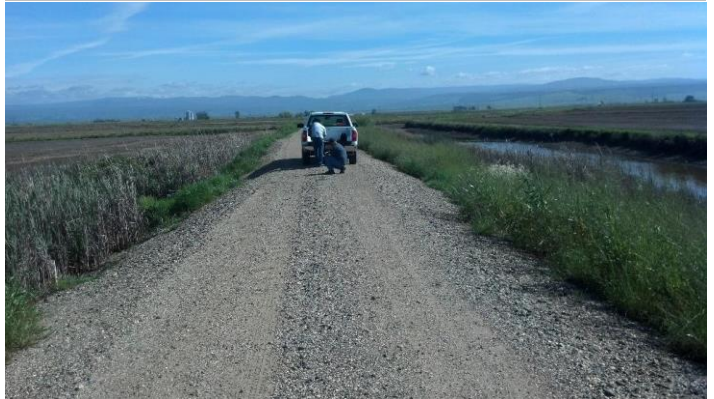
Photo 1 of 3 : UCIP_SP_2019_52124_67115.jpg

FS_ID:52124
DS_ID:16846
EP_NO: N/A
Repair Type: Non-Urgent
Crossing Status: Found
UCIP Comments: 6/5/2017 Both ends submerged during site visit. Pipe has been selected to be internally cleaned and inspected as part of the DMP project. (DWR Sutter Yard- A/Freitag)11/18/2016 Both pipe ends underwater for this inspection. (DWR Sutter Yard- A/Freitag)4/27/2016 Both pipe ends were underwater for inspection.7/01/2015 Both pipe ends and gates were fully submerged.5/29/2014 Same as last inspection.12/9/2013 Same as last inspection.7/10/2013 WS slope is cleared of vegetation and is in good condition. Both gates were fully submerged under water and unable to be inspected.4/19/2012 Rodent activity caused partial collapse on LS of levee in the vicinity of pipe. Limited inspection on WS slope due to dense vegetation. Limited inspection on gates due to both gates submerged under water.
FIELD_STRUCT_DESC: 36-inch corrugated metal drainage pipe through the levee, 9.3 feet below the crown. Flap gate on the waterside (WS) end. Slide gate on the landside (LS) end. Concrete "U" headwalls on both ends. Concrete sump area with flash boards to drain farmers field is located on farmer's property near drain inlet. [Additional Reference(s): DWR Levee Log, 1993. USACE Sacramento O&M Manual 519, June 1962 (HLM 4.20)]

Overview looking east on right bank of Cottonwood

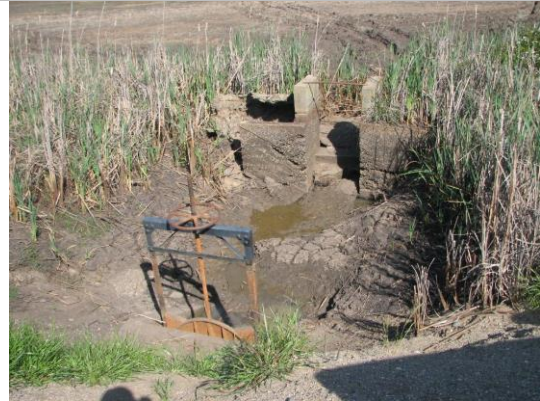
Photo 3 of 3 : UCIP_SP_2019_52124_67113.jpg

Overview of LS screw gate and concrete sump structure.

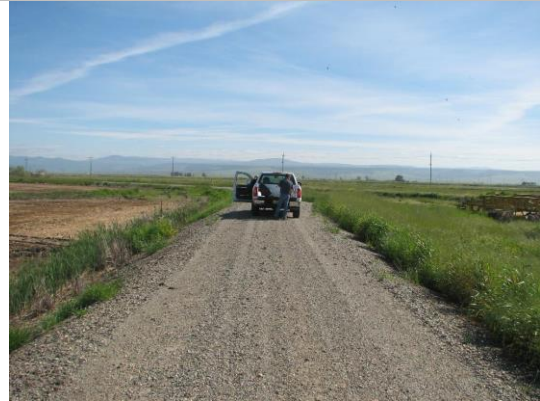
Photo 1 of 3 : UCIP_SP_2019_52125_67119.jpg

Comment Code						
Inspector Comment						
FS_ID:52125 DS_ID:16845 EP_NO: N/A Repair Type: No Action Needed Crossing Status: Found UCIP Comments: 6/5/2017 LS Slide gate mostly underwater due to rice field being flooded but crossing appears to be in good condition. Pipe has been selected to be internally cleaned and inspected as part of the DMP project. (DWR Sutter Yard- AFreitag)11/18/2016 Crossing appears to be in good condition. (DWR Sutter Yard- AFreitag)4/27/2016 Crossing appears to be in good condition.7/01/2015 Crossing appears to be in good condition. No noticeable issues to report.5/29/2014 Same as last inspection.12/9/2013 Same as last inspection.7/10/2013 WS slope has been cleared of vegetation and is in good condition.4/19/2012 Limited inspection due to dense vegetation on WS slope. Need photos of clear WS slope. FIELD_STRUCT_DESC: 24-inch corrugated metal drainage pipe through the levee, 5.6 feet below the crown. Flap gate on the waterside (WS) end. Slide gate on the landside (LS) end. Concrete "U" headwalls on both ends. [Additional Reference(s): DWR Levee Log, 1993. USACE Sacramento O&M Manual 519, June 1962 (HLM 4.69)] FS Date: 6/7/2017 1:41:34 PM

Overview looking east on right levee of Gold Run Creek (referred to Unit 2 of Cherokee Canal).

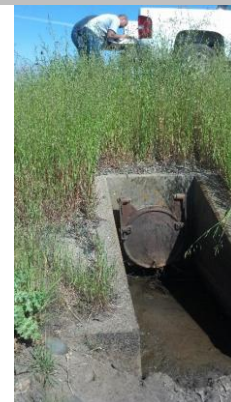
Photo 2 of 3 : UCIP_SP_2019_52125_67122.jpg

Headwall and flap gate located on WS.

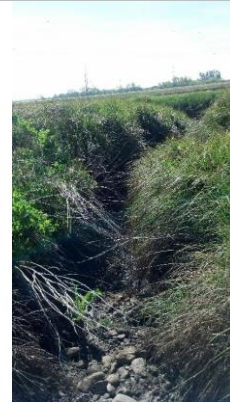
Photo 3 of 3 : UCIP_SP_2019_52125_67123.jpg

View of channel at crossing.

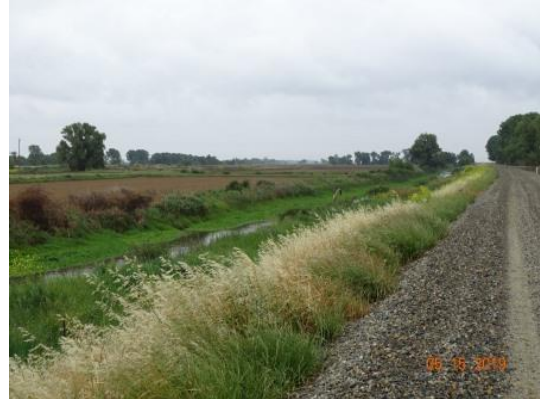
Photo 1 of 1 : SP_2019_MA0013_301_64_20190520_00133.jpg

LM Start	4.79	Rating **	U	Issue No.	64
LM End	21.15	Issue Type +	Ma	Location *	WS
Category	Earthen Levee			GPS Latitude/Longitude	
				Start	End
Item	Vegetation			39.526766 °	39.367786 °
				-121.684680 °	-121.856765 °
DWR ID	DWR_MA0013_02_s_2019_64				
Comment Code					
V1 : Control annual grass and weeds on the levee slopes and easements.					
Inspector Comment

View of the vegetation on the waterside slope. Spring 2019.

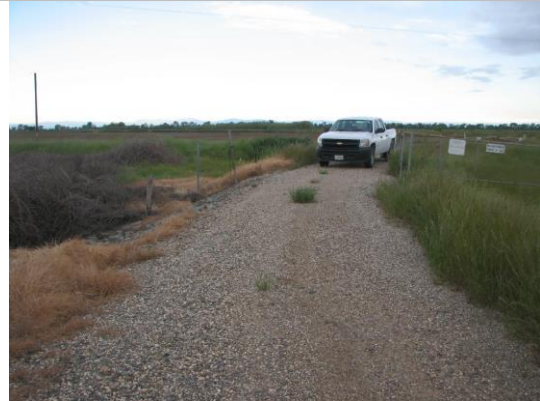
Photo 1 of 3 : UCIP_SP_2019_52126_67131.jpg

Comment Code					
Inspector Comment					
FS_ID:52126 DS_ID:16395 EP_NO: N/A Repair Type: No Action Needed Crossing Status: Found UCIP Comments: 6/5/2017 WS mostly submerged but crossing appears to be in good condition.(DWR Sutter Yard-AFreitag)11/18/2016 Crossing appears to be in good condition. Pipe is a 30" cmp. (DWR Sutter Yard- AFreitag)4/27/2016 Crossing appears to be in good condition.6/30/2015 Erosion on LS does not appear to be getting any worse with the rip-rap there. WS pipe end and gate appeared in good condition.5/29/2014 Same as last inspection.12/9/2013 Same as last inspection.7/09/2013 Same as last inspection.4/19/2012 Rusted pipe debris located on WS. Remove pipe debris on WS and monitor the LS erosion near headwall. Rip-rap used to protect LS headwall from erosion. Was pipe exposed prior to dumping rock? Erosion on the LS could have exposed pipe. Dense shrub on the LS could restrict flow. FIELD_STRUCT_DESC: 30-inch corrugated metal drainage pipe through the levee, 8.6 feet below the crown. Flap gate on the waterside (WS) end. Concrete "U" headwalls on both ends. [Additional Reference(s): DWR Levee Log, 1993. USACE Sacramento O&M Manual 519, June 1962 (HLM 5.06)] FS Date: 6/7/2017 1:54:08 PM

Overview looking west on the left levee of Cottonwood

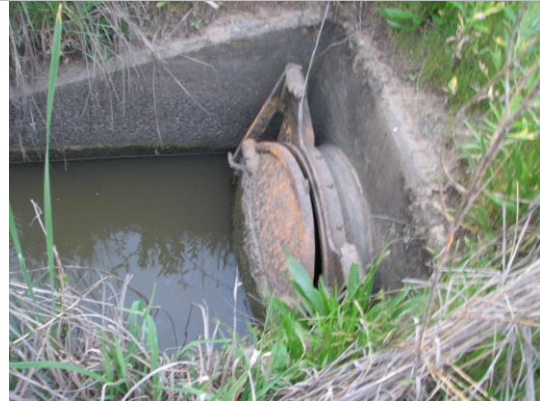
Photo 2 of 3 : UCIP_SP_2019_52126_67129.jpg

Headwall and flap gate located on WS.

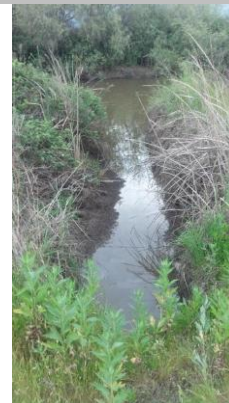
Photo 3 of 3 : UCIP_SP_2019_52126_67126.jpg

View of channel at crossing.

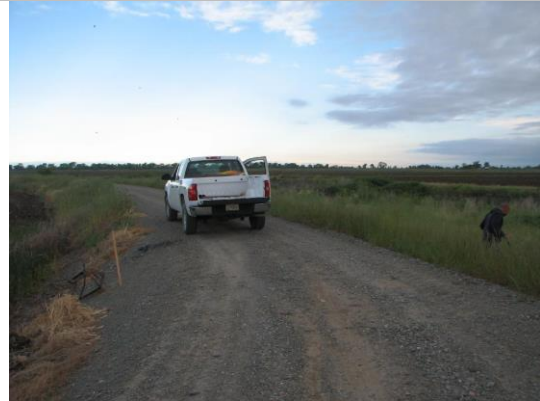
Photo 1 of 3 : UCIP_SP_2019_52129_67138.jpg

FS_ID:52129
DS_ID:16408
EP_NO: N/A
Repair Type: No Action Needed
Crossing Status: Found
UCIP Comments: 6/5/2017 Crossing appears to be in good condition. Pipe has been selected to be internally cleaned and inspected as part of the DMP project. (DWR Sutter Yard- A Freitag)11/18/2016 Crossing appears to be in good condition. (DWR Sutter Yard- A Freitag)4/27/2016 Crossing appears to be in good condition.6/30/2015 Crossing appears to be in good condition. No apparent issues to report.5/29/2014 Same as last inspection.12/9/2013 Same as last inspection.7/09/2013 WS and LS slopes have been cleared of vegetation and are in good condition. Slide gate on LS has been replaced.4/24/2012 Slide gate is damaged, needs to be replaced. Limited inspection on WS slope and toe due to dense vegetation. Need photos of clear WS slope and toe. This crossing was listed in the USACE Periodic Inspection report as Corp's inspection ID# USACE_CESPK_M13H_2011_p_0026 for broken gate on LS.

Overview of levee crown at crossing looking west.

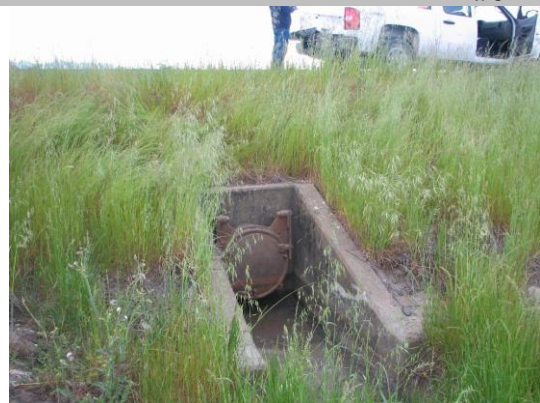
Photo 2 of 3 : UCIP_SP_2019_52129_67140.jpg

Headwall and flap gate located on WS.

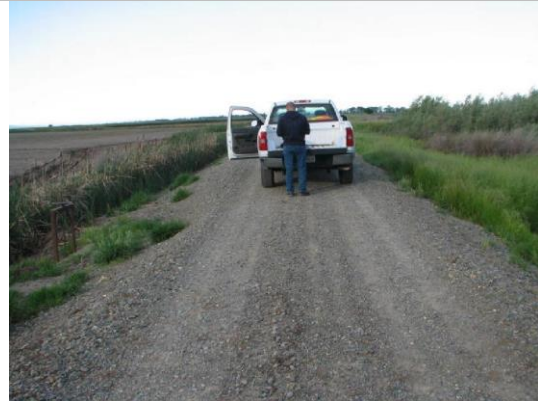
Photo 1 of 3 : UCIP_SP_2019_52130_67146.jpg

FS_ID:52130
DS_ID:16409
EP_NO: N/A
Repair Type: Non-Urgent
Crossing Status: Found
UCIP Comments: 6/5/2017 WS fully submerged and LS slide gate mostly buried by sediment. Pipe has been selected to be internally cleaned and inspected as part of the DMP project. (DWR Sutter Yard-AFreitag)11/18/2016 There is a flapgate on the WS and a slide gate on the LS. The LS slide gate appears to be partially buried and blocked by vegetation. (DWR Sutter Yard- AFreitag)4/27/2016 LS slide gate is blocked by vegetation. Pipe appears to not be used.6/30/2015 WS flap gate was still overgrown with vegetation. Needs to be cleared away.5/29/2014 Same as last inspection.12/9/2013 Same as last inspection.7/09/2013 Same as last inspection.4/24/2012 Limited inspection on WS slope due to dense vegetation. Need photo of clear WS slope during next inspection. This crossing was listed in the USACE Periodic Inspection report as Corp's inspect ID# USACE_CESPK_M13H_2011_p_0035 non-functional crossing due to overgrown vegetation on WS flap gate.

Overview of crossing looking downstream.

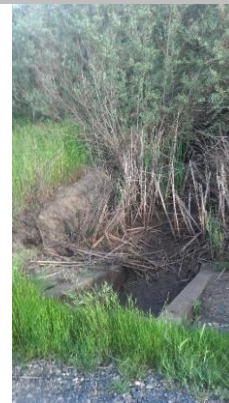
Photo 2 of 3 : UCIP_SP_2019_52130_67149.jpg

View of WS headwall with dense vegetation in channel.

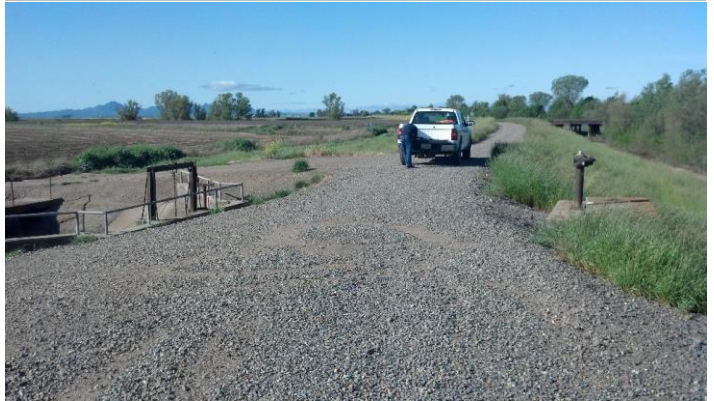
Photo 1 of 3 : UCIP_SP_2019_52145_67280.jpg

Overview of levee crown at crossing looking D/S.

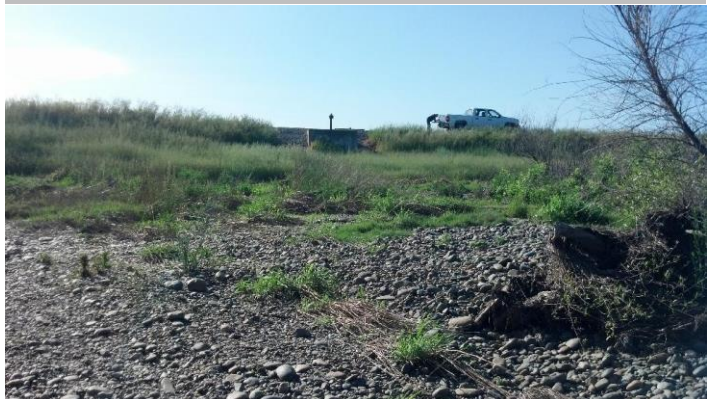
Photo 2 of 3 : UCIP_SP_2019_52145_67285.jpg

View of crossing looking from channel towards WS levee.

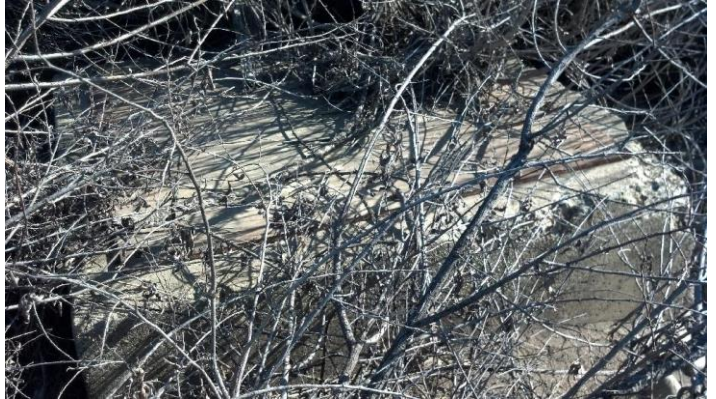
Photo 3 of 3 : UCIP_SP_2019_52145_67283.jpg

WS view-access well located 60 feet from WS toe.

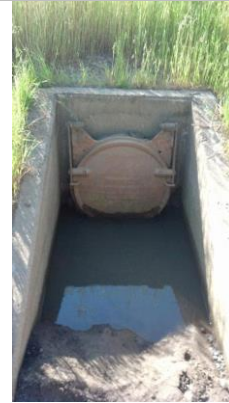
Photo 1 of 3 : UCIP_SP_2019_52146_67289.jpg

WS view of crossing. Dense vegetation along WS slope limited visual inspection. (WS Photo 1 of 2)

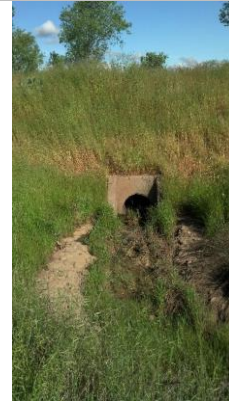
Photo 3 of 3 : UCIP_SP_2019_52146_67286.jpg

View of crossing from LS. Dense vegetation along LS slope limited visual inspection. (LS Photo 1 of 2)
